CONTEXT

At the Nigerian Red Cross' request, the IFRC deployed an Advance WASH ERU Team Leader to assess needs and recommend appropriate support. Assessments revealed serious disruptions to clean water access and highlighted the need for borehole rehabilitation. As a result, a WASH ERU: Water Supply Rehabilitation was deployed. This Case Study focuses specifically on the sustainability aspects of the WSR approach.

Water Supply Rehabilitation ERU

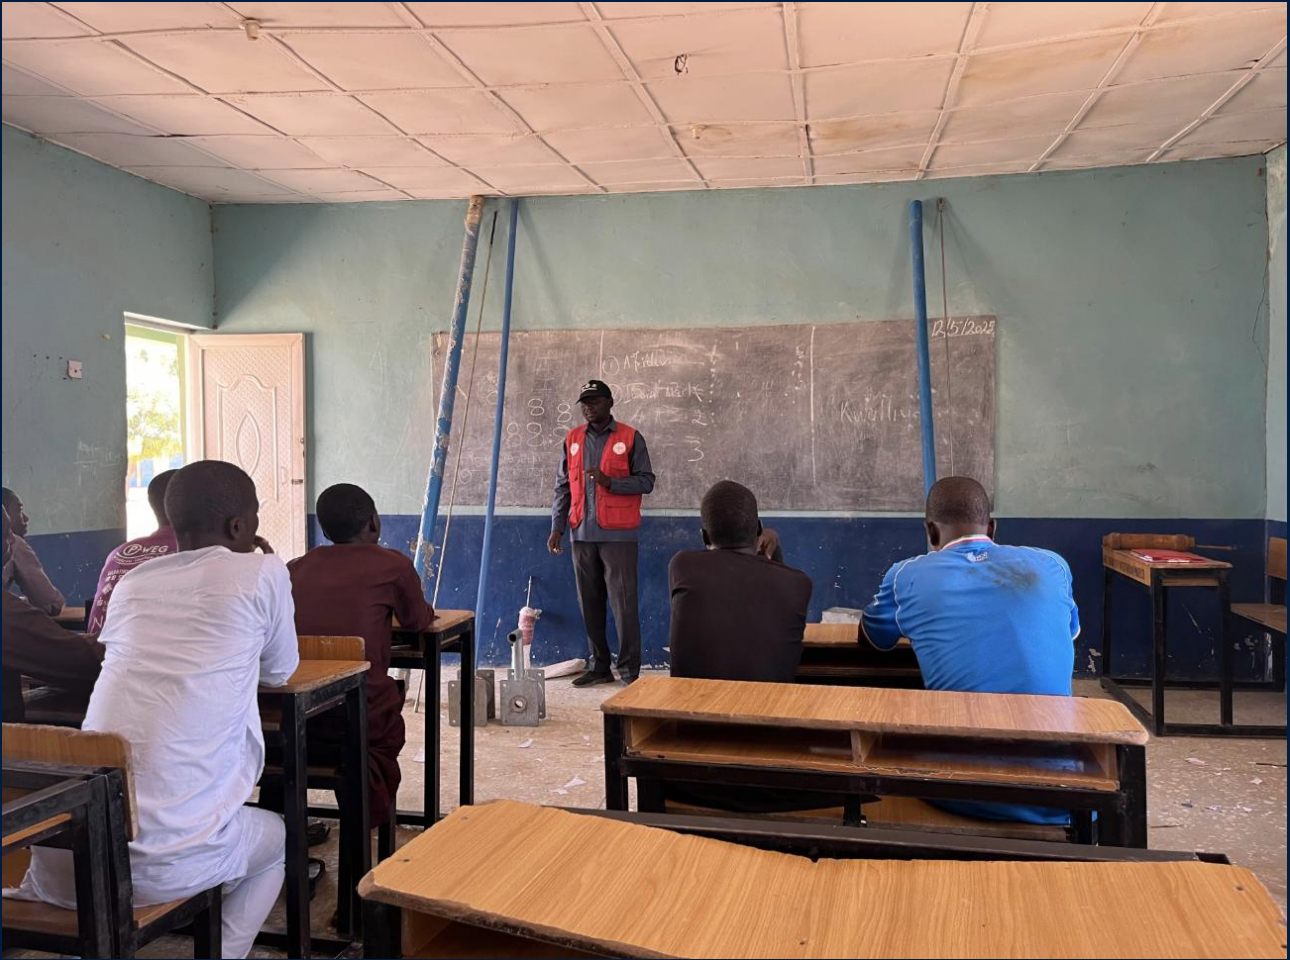
Nigerian Red Cross staff member carries out a training for the water committees in Bauchi State, Nigeria. After the training they are able to repair commonly occurring issues with the Afridev Handpumps that are fitted into their boreholes.

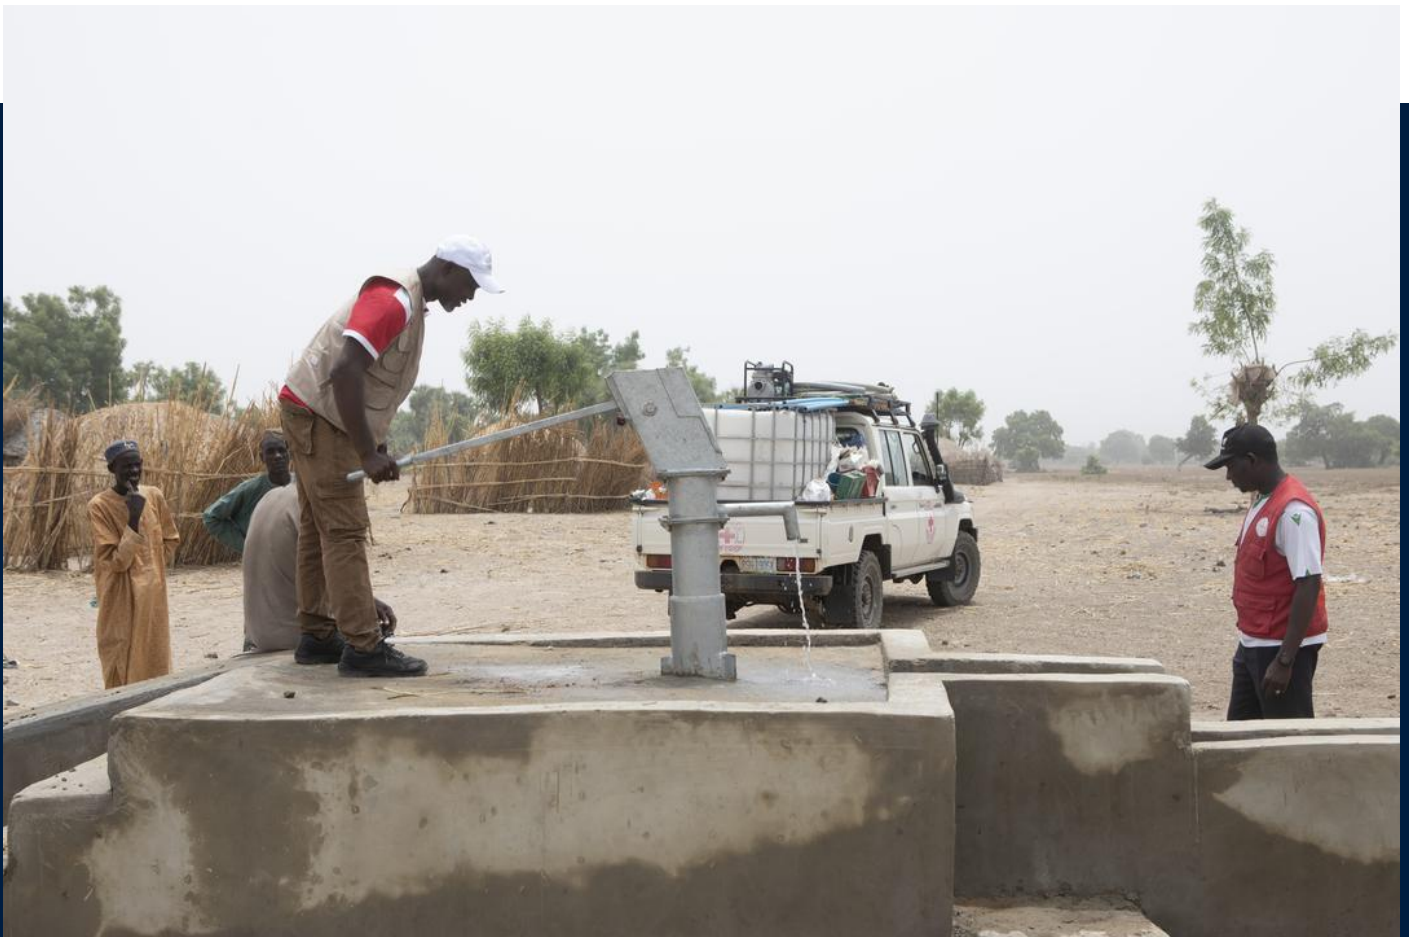
Due to the specificity of system, standardization of ERU equipment is not possible, thus the WSR ERU is a very lightly equipped ERU and rely on local markets for supply of goods and services. NS WASH Eng. is checking the state of a newly constructed elevated apron in Bauchi State, Nigeria.

Building back Better – the approach went beyond simply repairing damaged water-pump components. The team also elevated 50 boreholes aprons above ground level to safeguard them against future flooding ensuring long term access to clean water for the communities even in times of flooding.

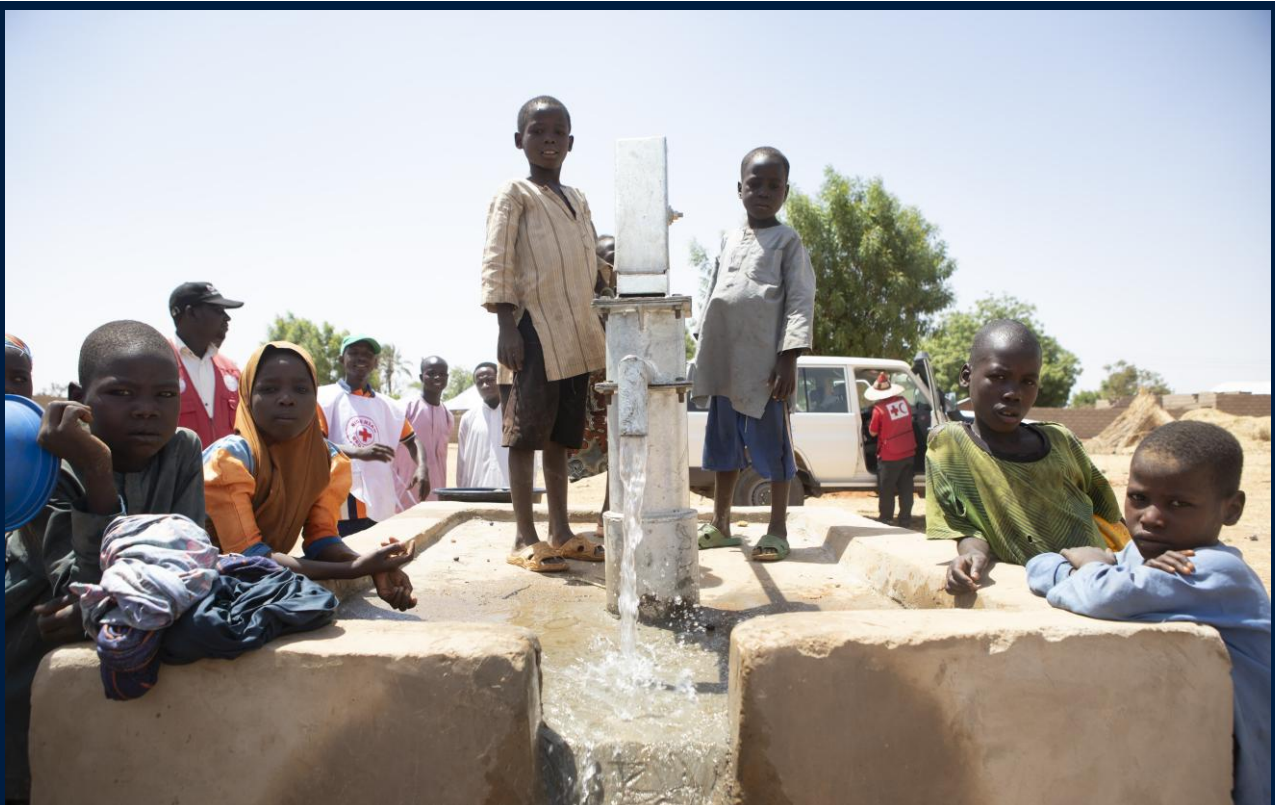
The elevated apron in the borehole will ensure a minimum access to safe water during next floods in the locations where the WSR ERU was present in Bauchi State, Nigeria.
