**THE FOLLOWING CARDS ARE
DISTRIBUTED AROUND THE
TRAINING ROOM IN
DIFFERENT LOCATIONS.
PARTICIPANTS CAN ASK
FURTHER INFORMATION OF
COMMUNITY MEMBERS. THEY
SHOULD COMMENT ON RISK,
RECOMMEND ANY
APPROPRIATE TESTING,
PROTECTION, TREATMENT
AND SIGNS TO BE POSTED**

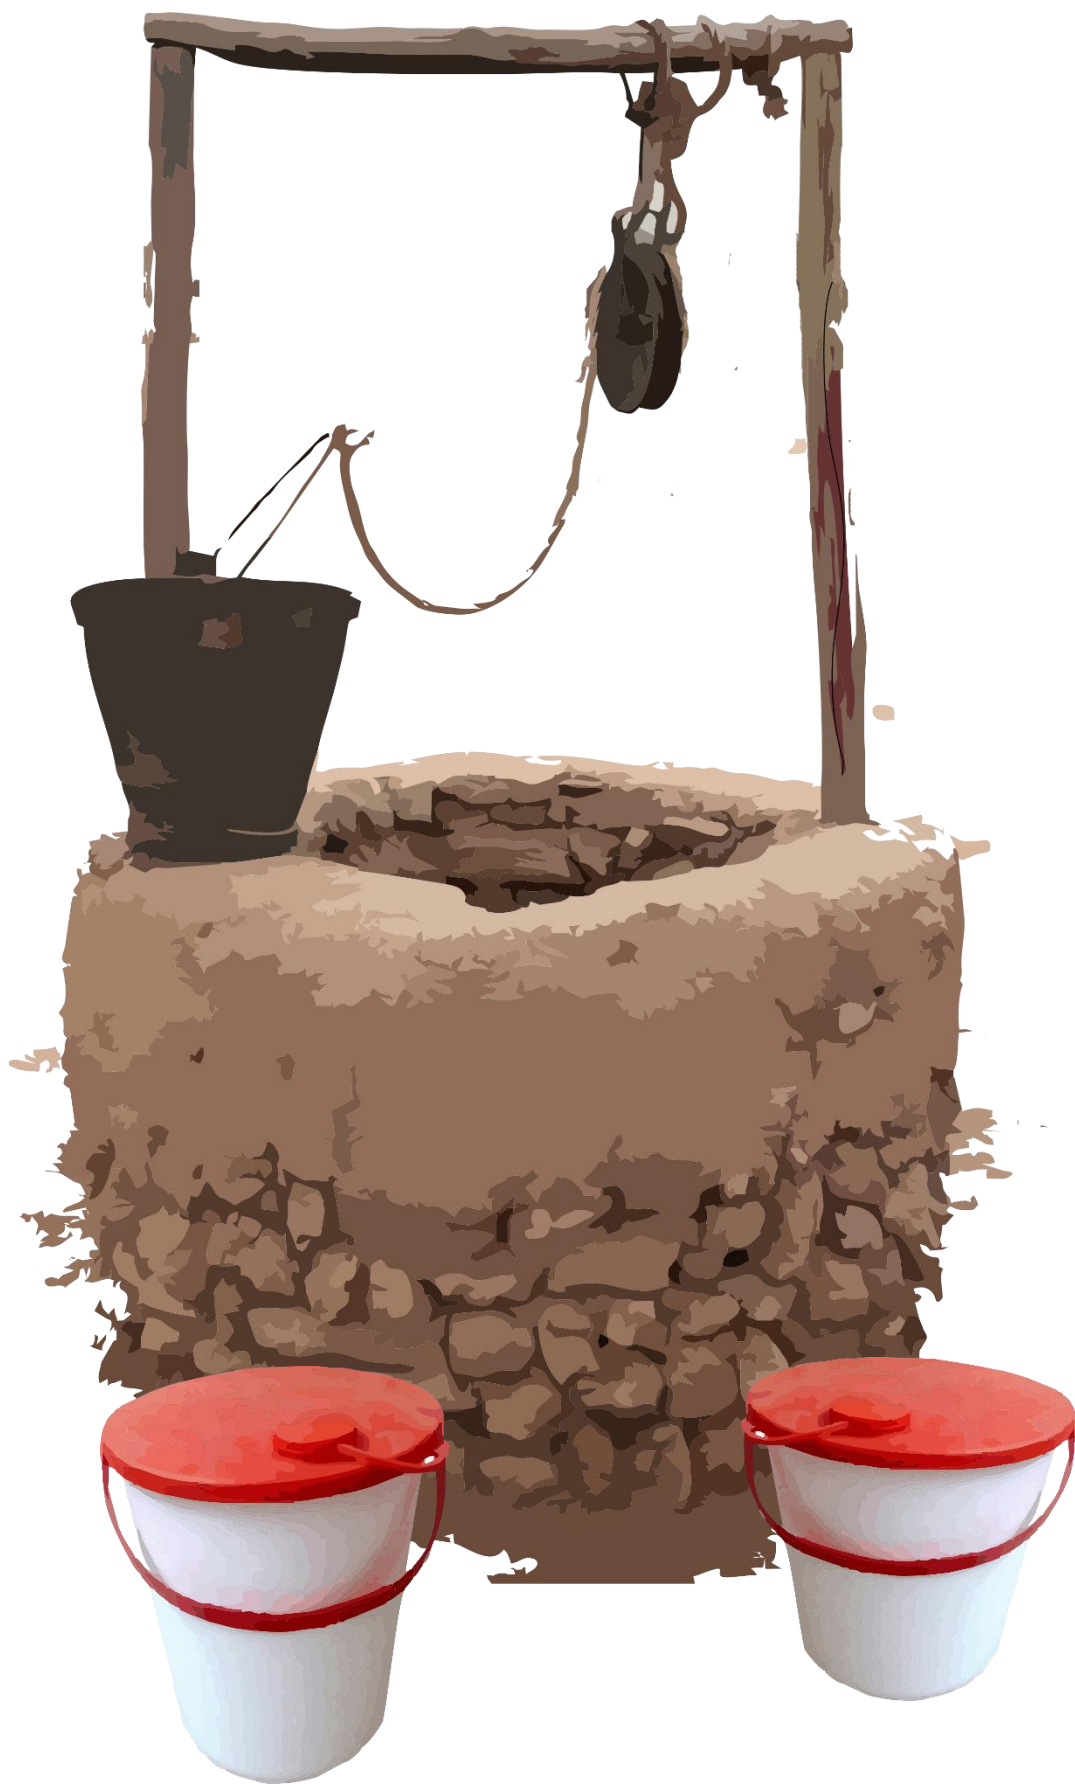
Unprotected well

Location: village periphery. Status: functional.

Villagers explain: This is used only for washing.
Nobody drinks it.

Even if drinking water (it is not) this should
NOT be tested. Assume it contains microbial
contamination. Testing wastes resources.

No action to well required. No testing. But
could recommend hand hygiene if handling
without soap.

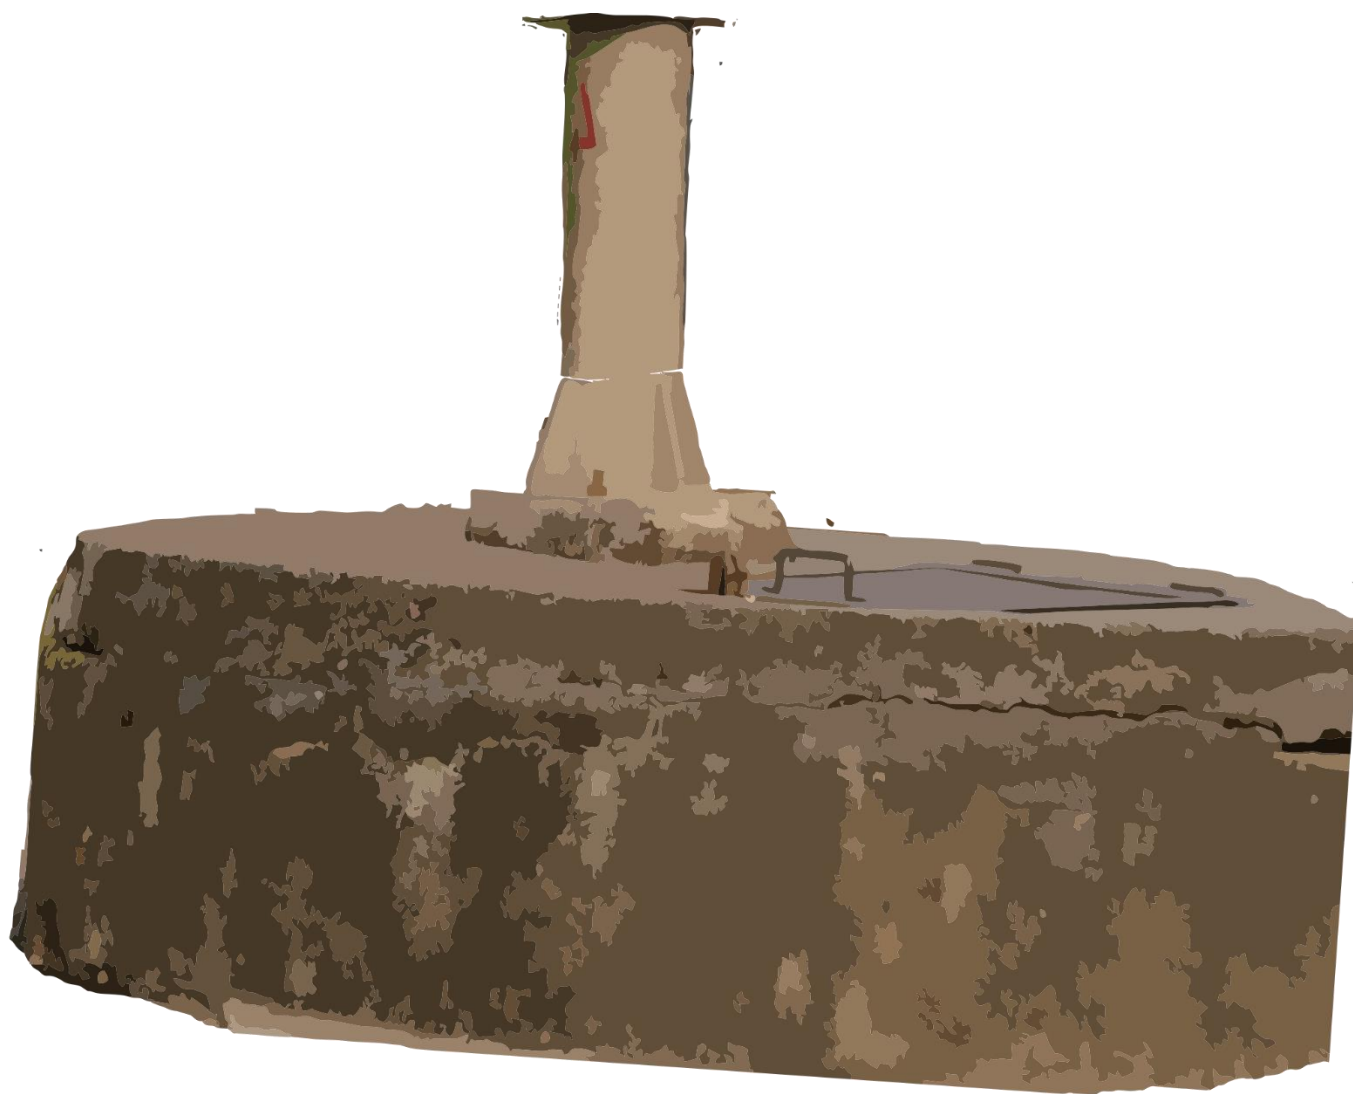
Dismantled well 2

Reason: insufficient drill depth, hardware used elsewhere.

No action required. Other wells in existence.

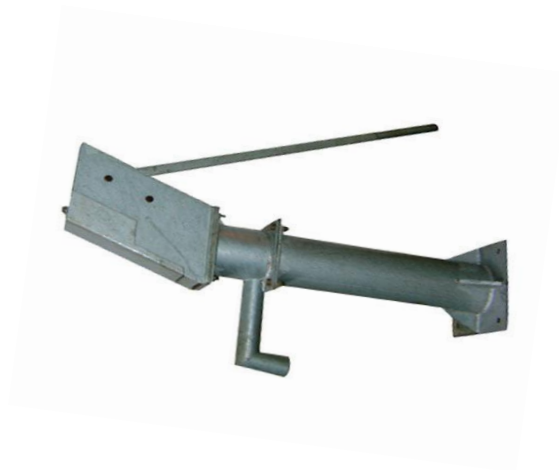
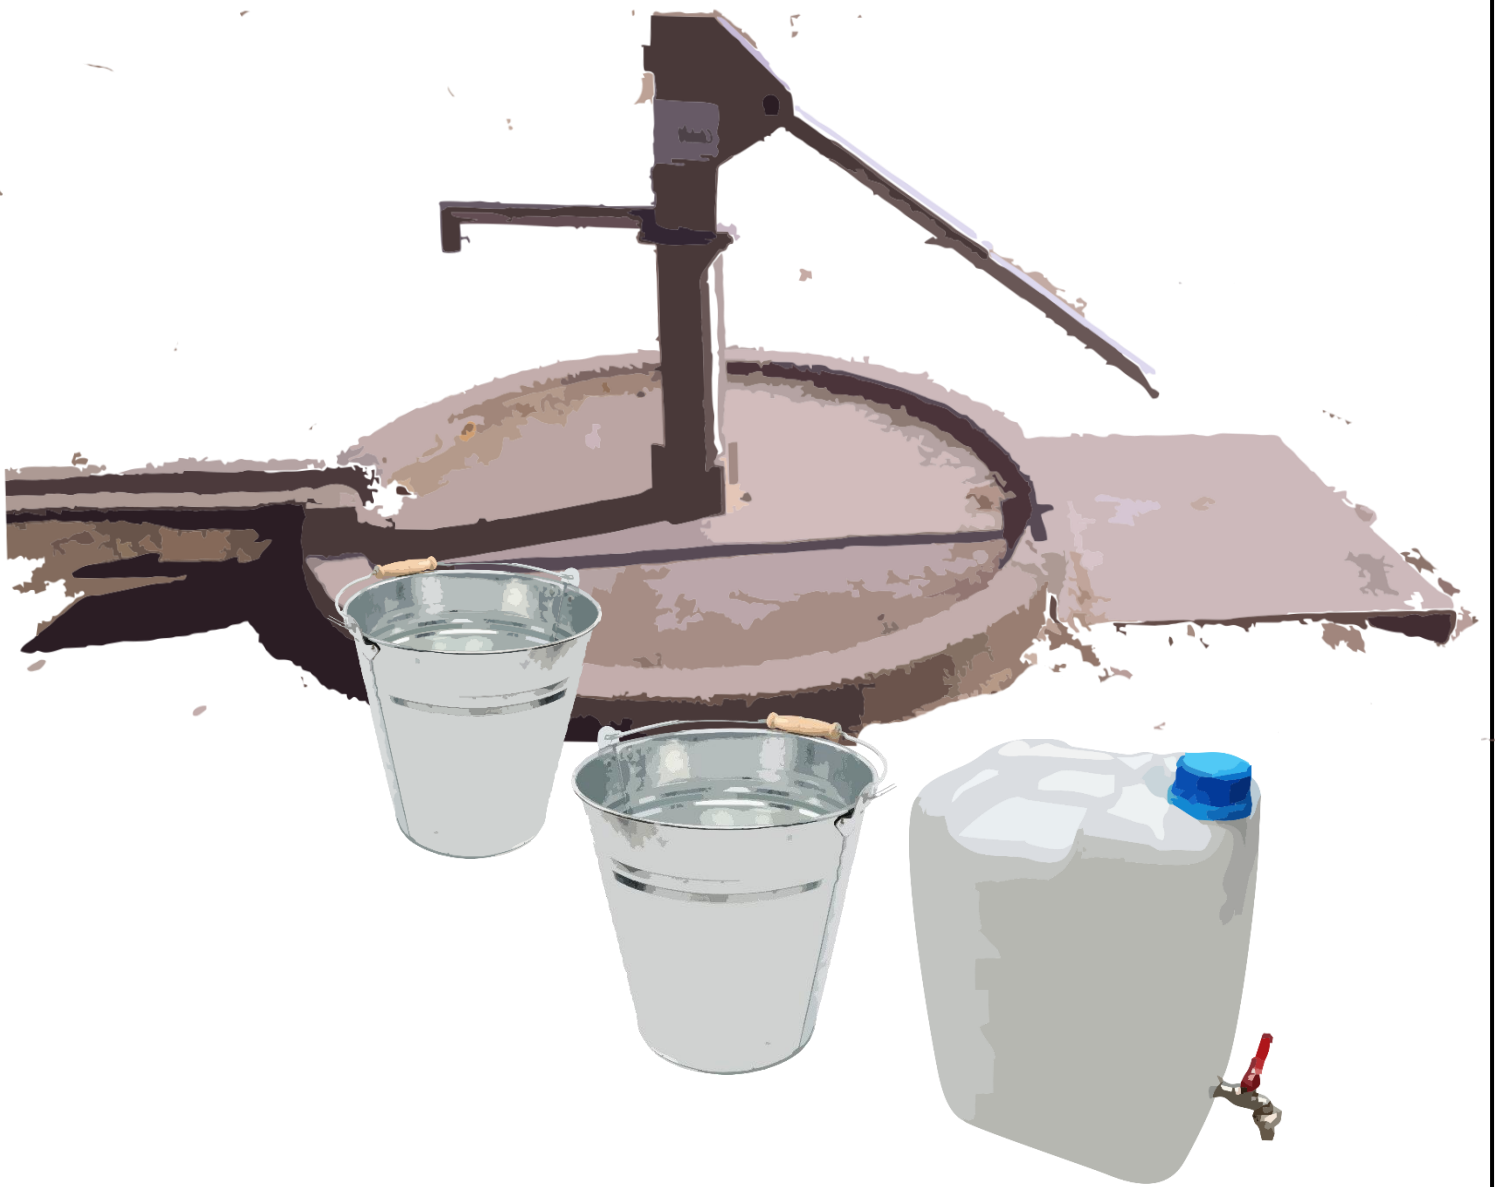
Tube well

Location: Near school but public. Status: functional. Good flow. Estimated 60m.

Superficial cracks to apron.

This is a good, protected well. functioning all year. The superficial cracking is not a risk and is not contributing to cholera. The well can be tested. There are no nearby latrines. The containers are a mix of protected and unprotected. They may have different uses (cleaning and drinking).

Testing could be done for microbial contamination. Install chlorinator and signs, handwashing station (and water/soap replenishment system). Recommend protected containers for drinking water

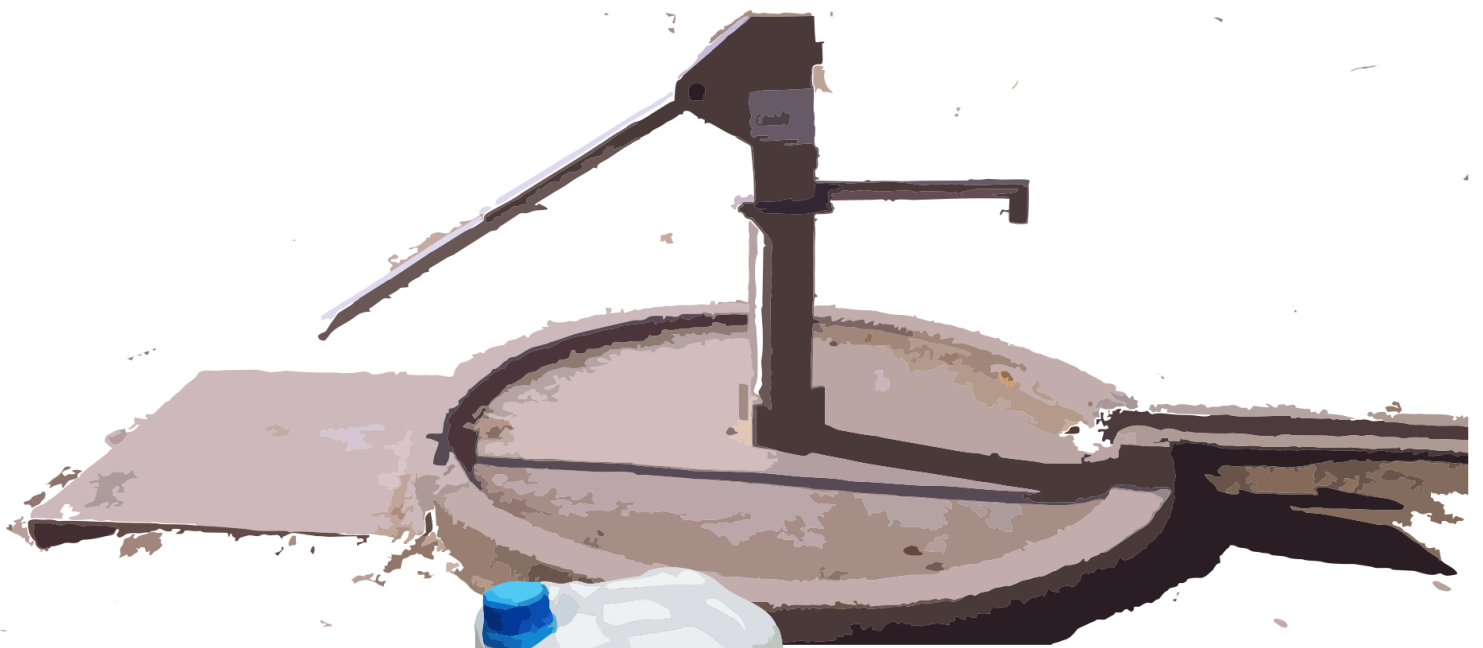
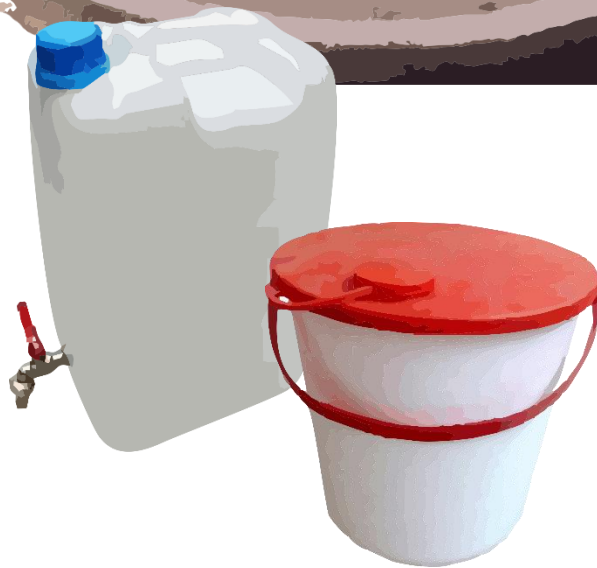
Tube well 2

Location: Near mosque but public. Status: functional. Some evidence of loss of flow (requires delay between pumping) but adequate. Estimated 40m

This is a good, protected well. functioning all year. The superficial cracking is not a risk and is not contributing to cholera. The well can be tested. There are no nearby latrines. The containers visible are all protected.

Testing could be done for microbial contamination. Install chlorinator and signs, handwashing station (and water/soap replenishment system). Recommend protected containers for drinking water

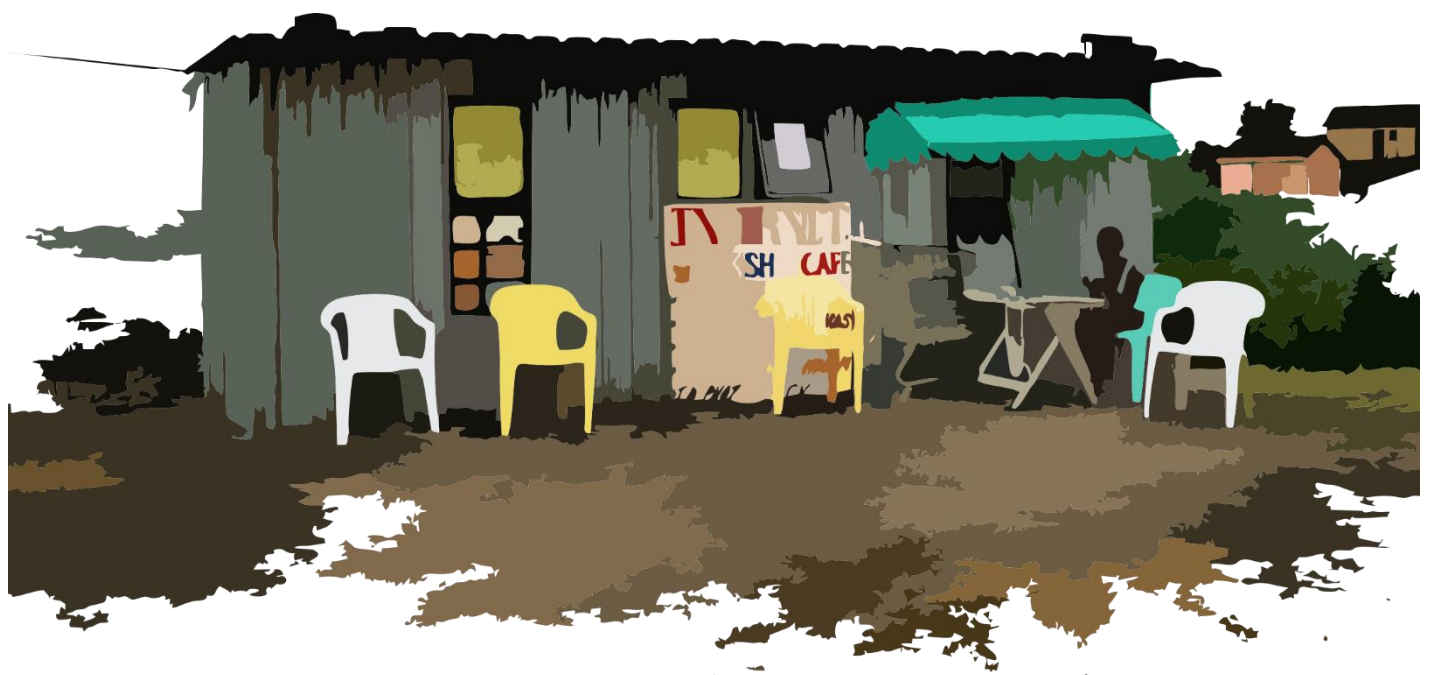
Internet Café

Location: Centre of town. The café also serves water (free) and other drinks (sold).

The owner, if asked, reveals their water is from a truck which delivers every 2 weeks. If they ask about source and storage, reveal other cards.

Install handwashing station (and water/soap replenishment system). Chlorinate tank.

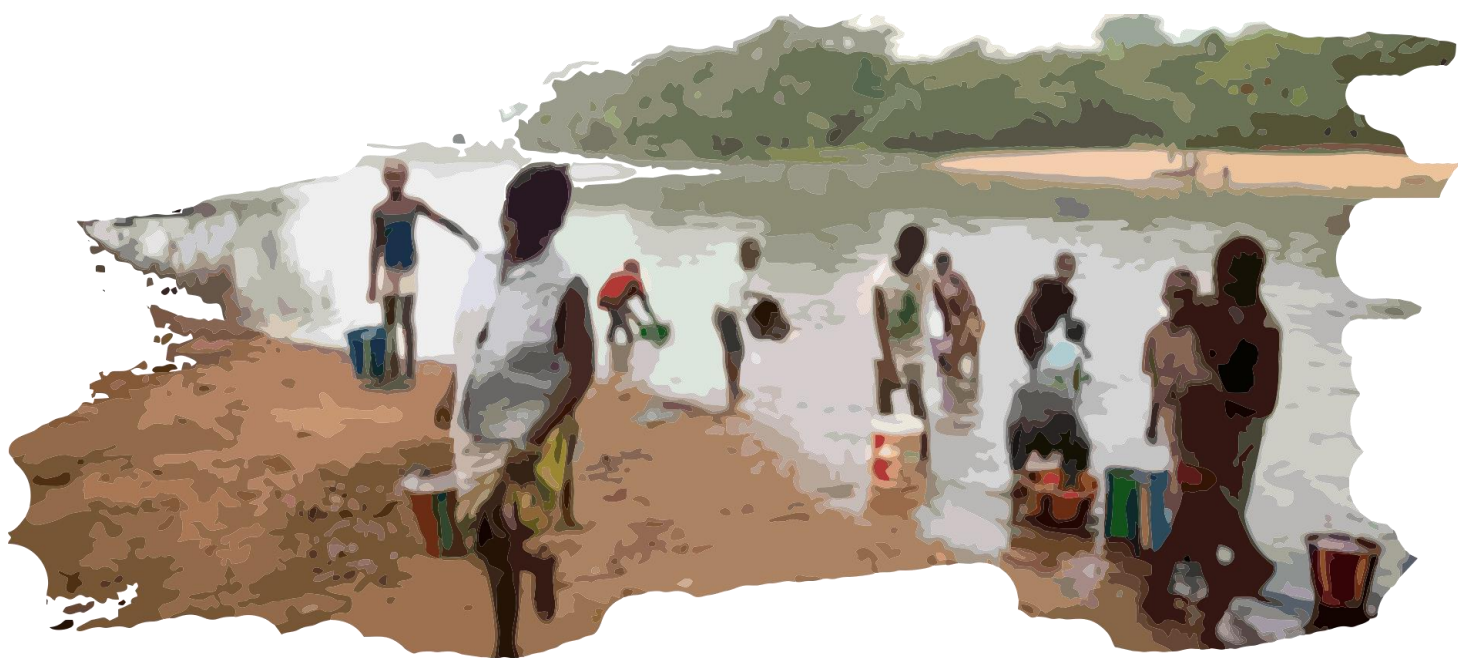
Surface water

Location: River on edge of village.

People collect water and wash clothes in the river. If asked, they only clean with the water.
Nobody drinks it.

No action required. But could recommend hand hygiene if handling without soap.

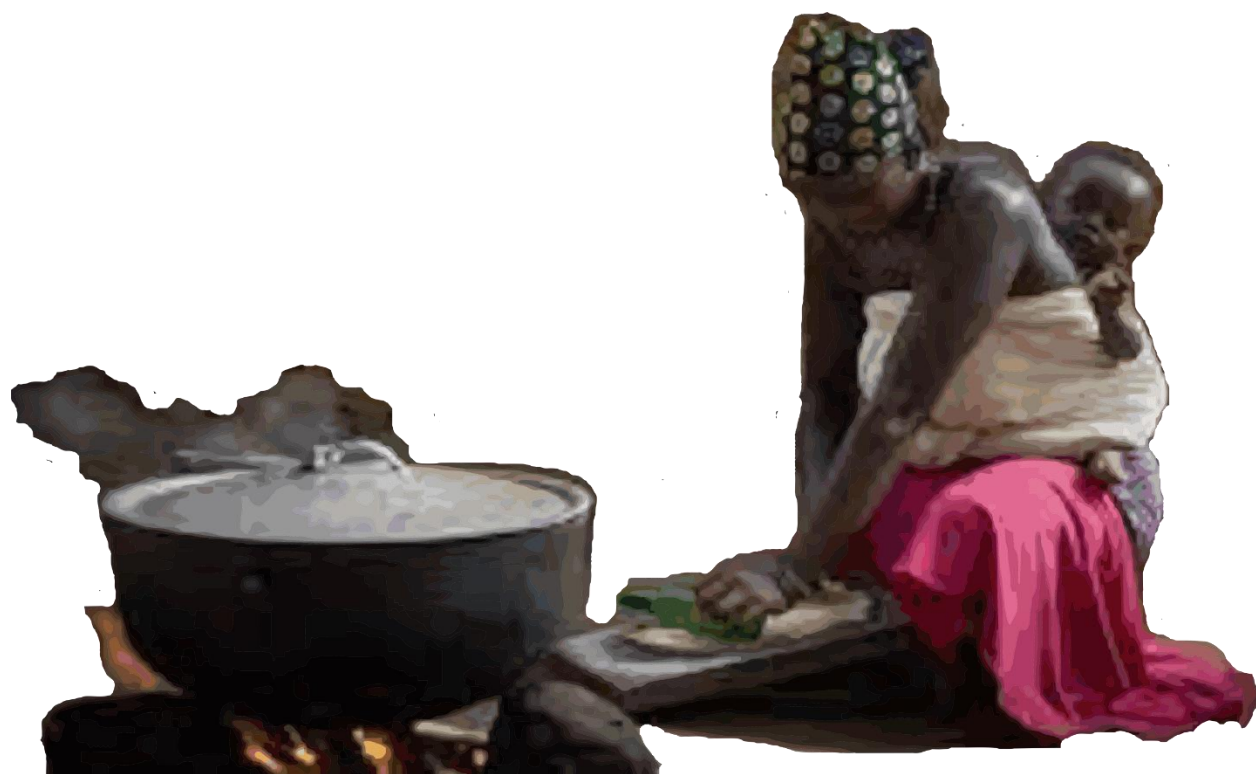
Commercial cooking

Location: Centre of town adjacent to internet café. Stall selling boiled and fried food. Cooked to order. Chicken, fish, potatoes. Free water with food, Coke, Fanta.

The water is from the Internet café. No food is stored – it is all cooked to order. There is no handwashing station.

Install handwashing station (and water/soap replenishment system). Chlorinate water. Supply Aquatabs and instructions for future use.

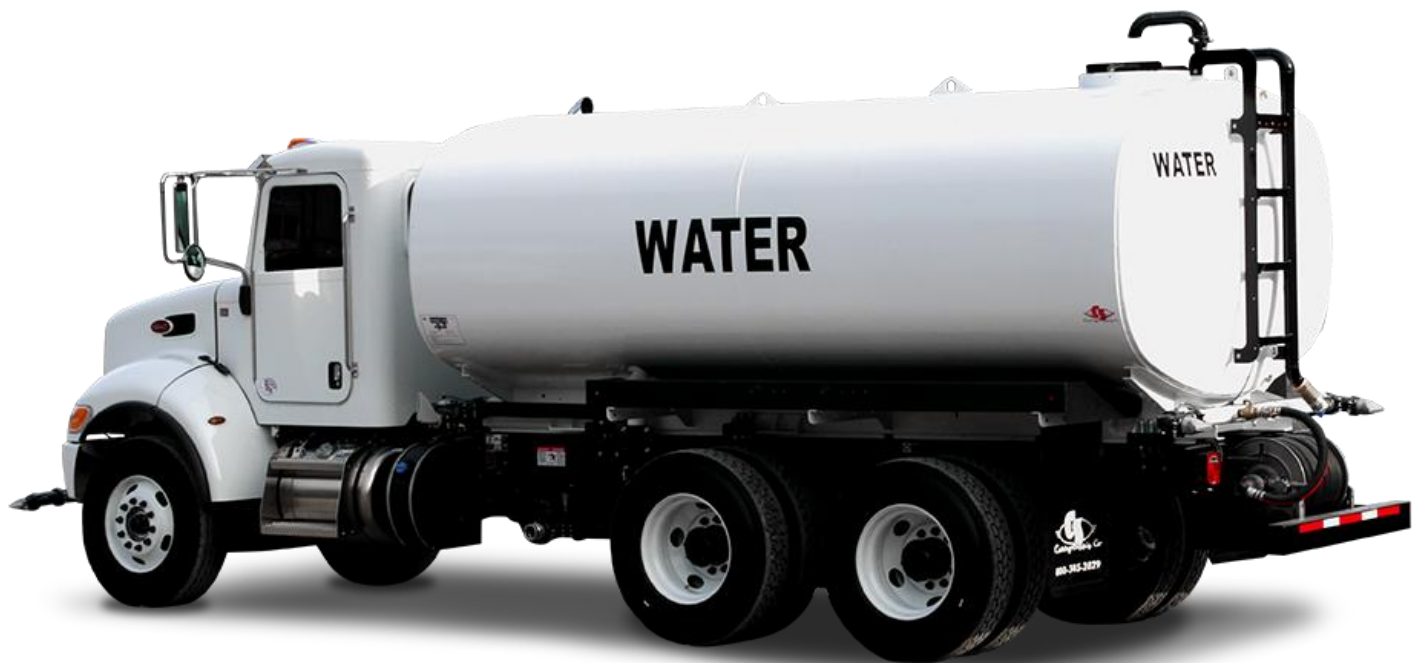
Water trucking for commercial properties

Source: tube well with diesel pump in nearest
large town. Protected

This cannot be tested as it arrives in 2 weeks.

No action possible unless able to visit source.
Visits every 2 weeks

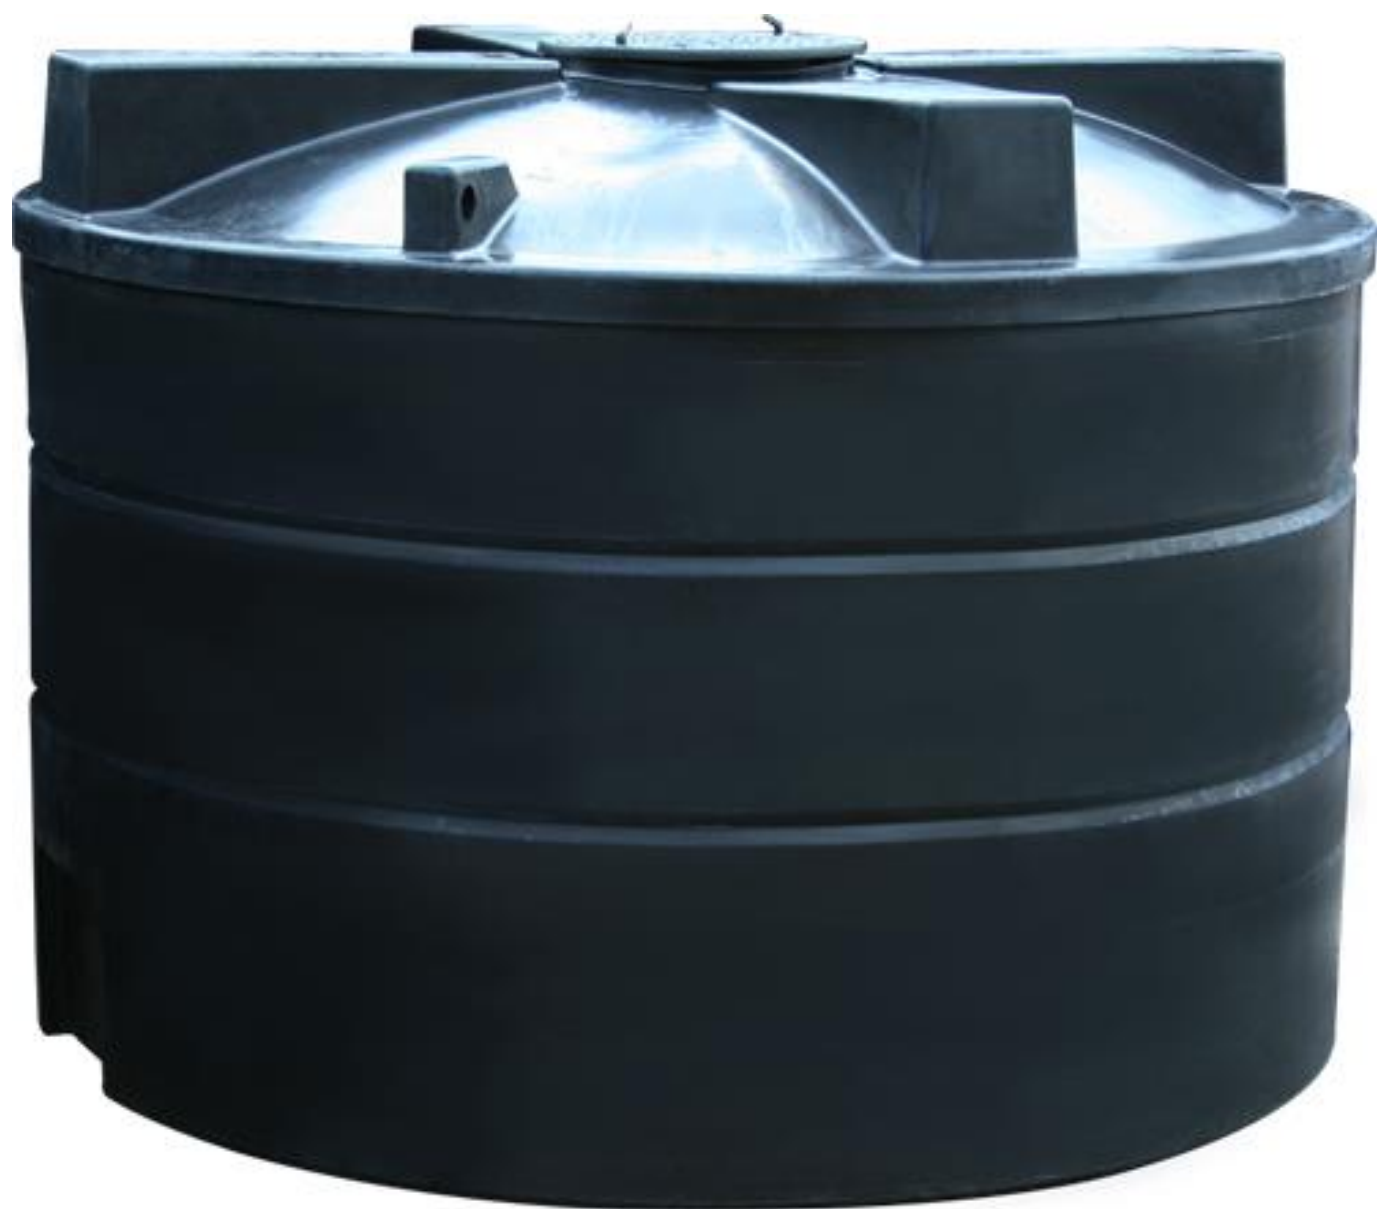
Storage container

Location: Behind internet café. Used solely by café. Status: Private, raised on brick platform.

Tap for extraction. Capacity 7200 litre

This can be tested for chlorine and microbial contamination. [As mentioned] install handwashing station in café (and water/soap replenishment system), chlorinate bulk water. Supply Aquatabs and instructions for future use.
